**HOME INSPECTION REPORT
120 WEMBELTON WAY HUNTSVILLE, ALABAMA**

**Inspection Date:
APRIL 21 , 2015**

Report Number:
0522

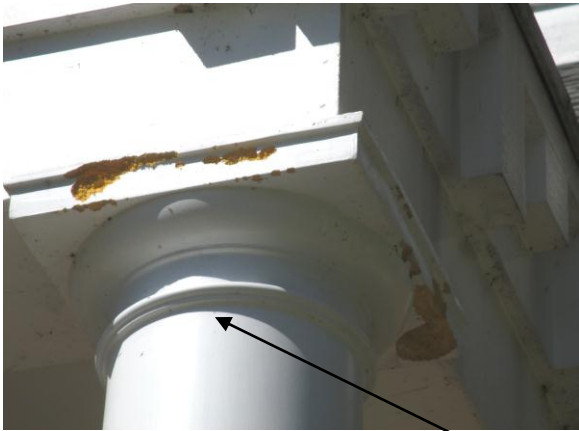
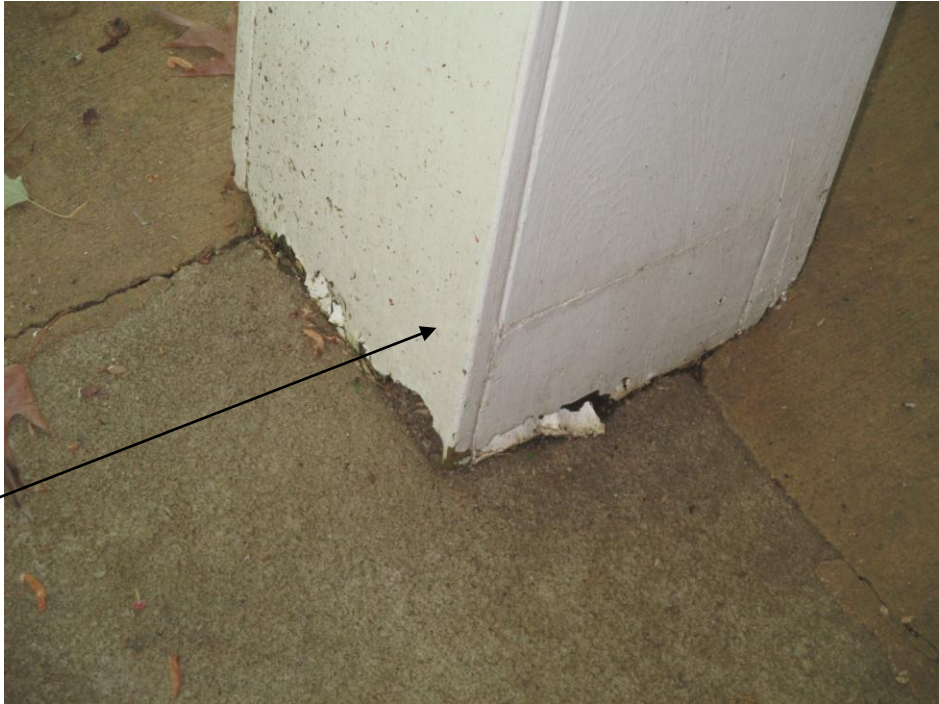
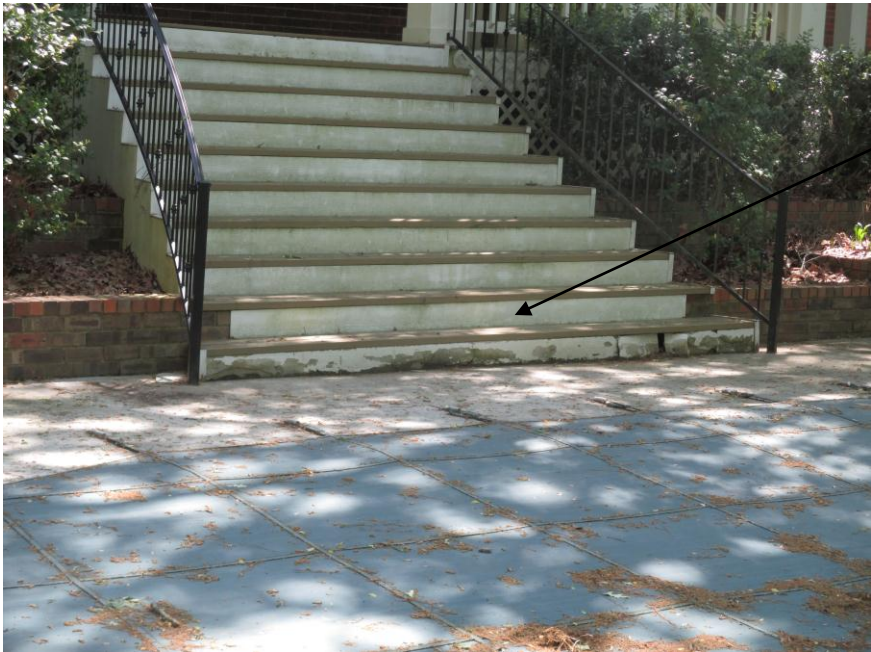
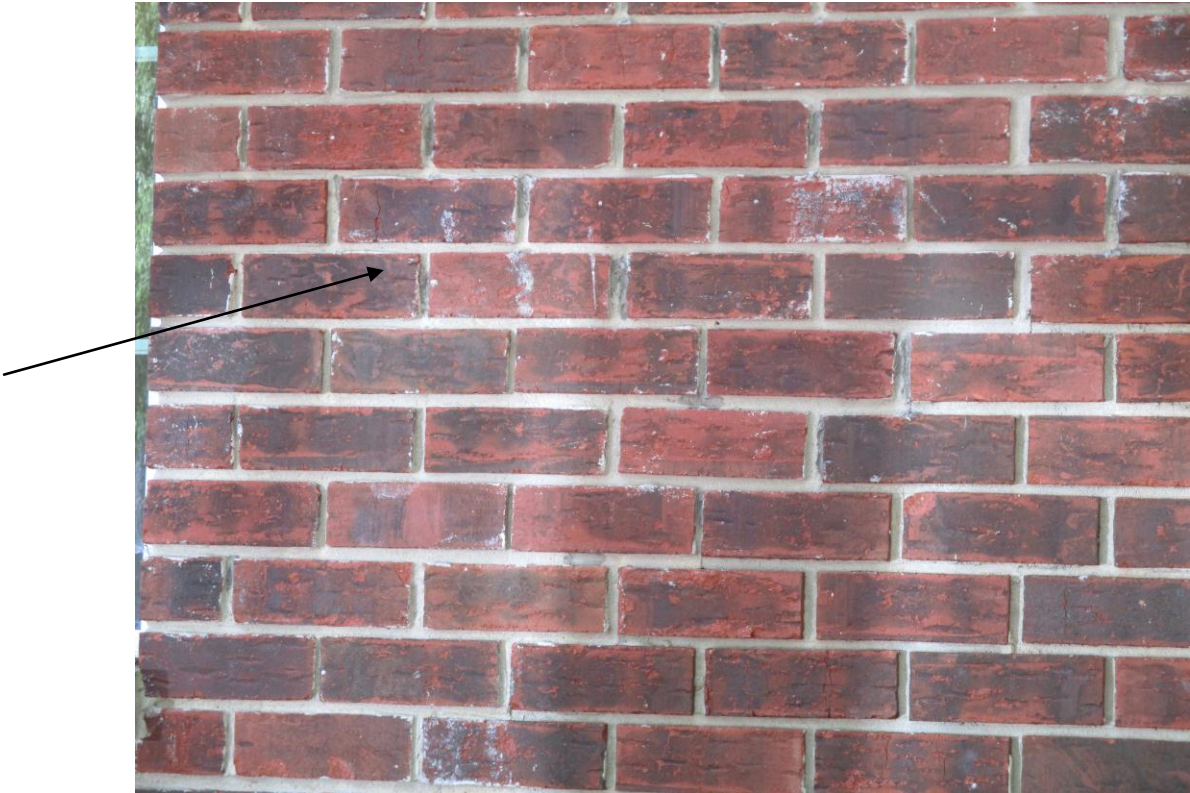
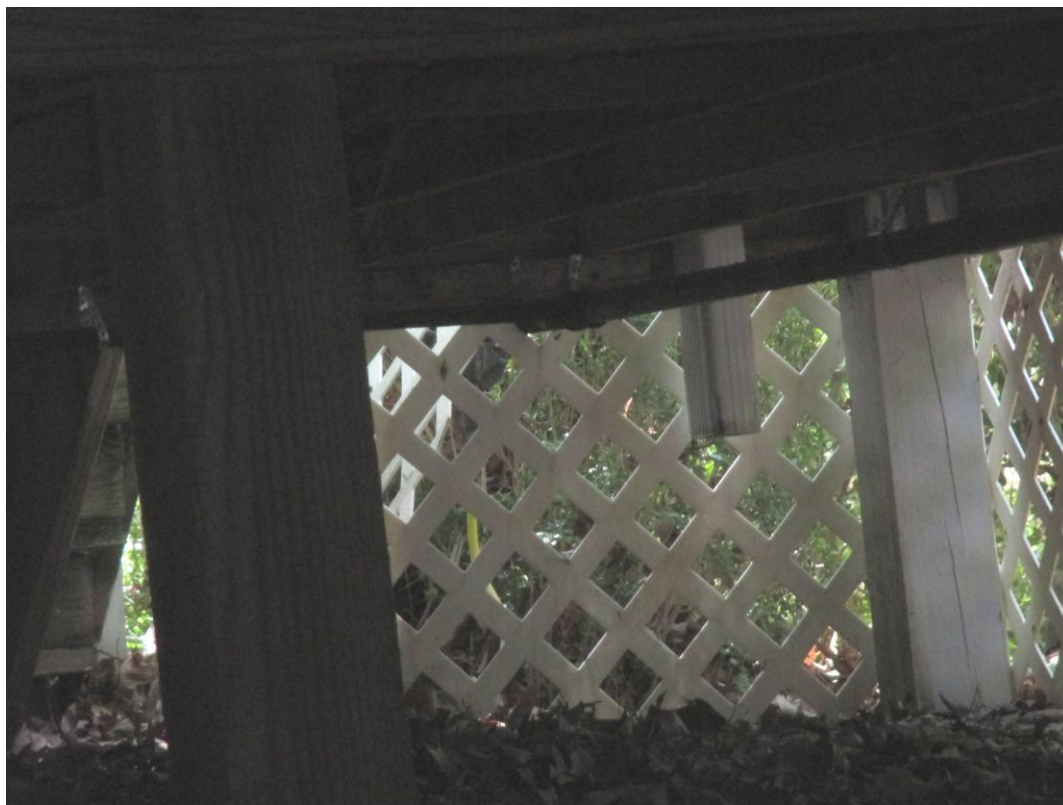
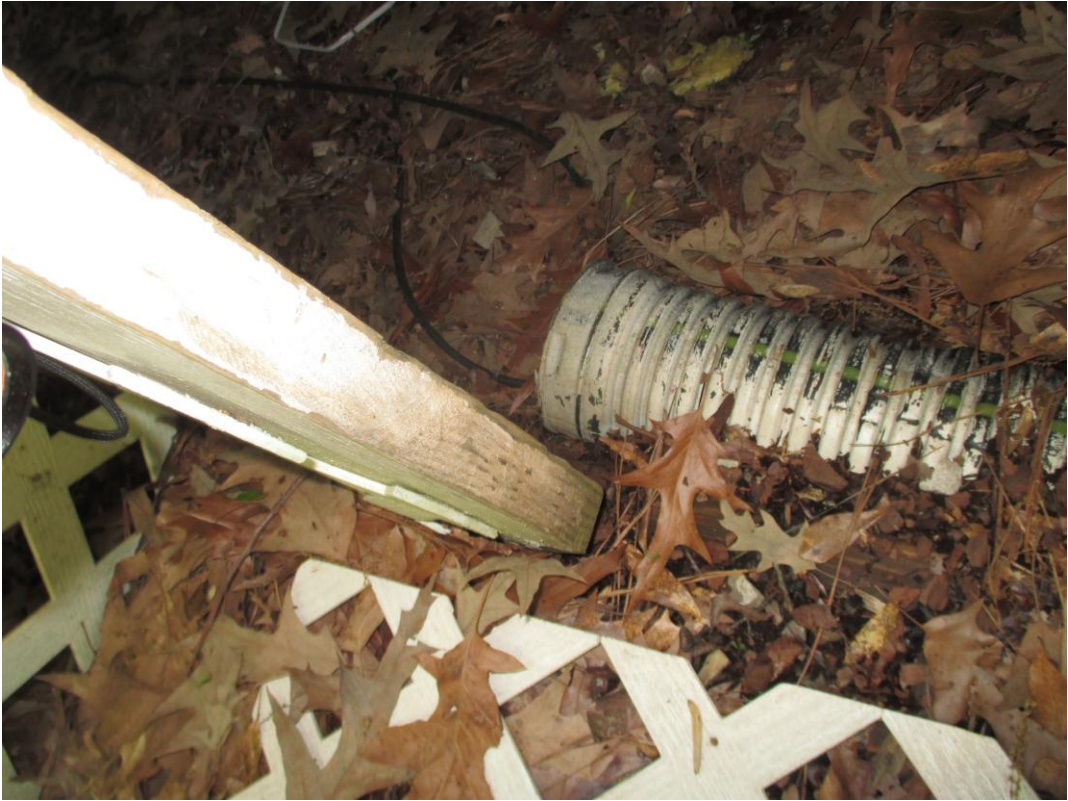
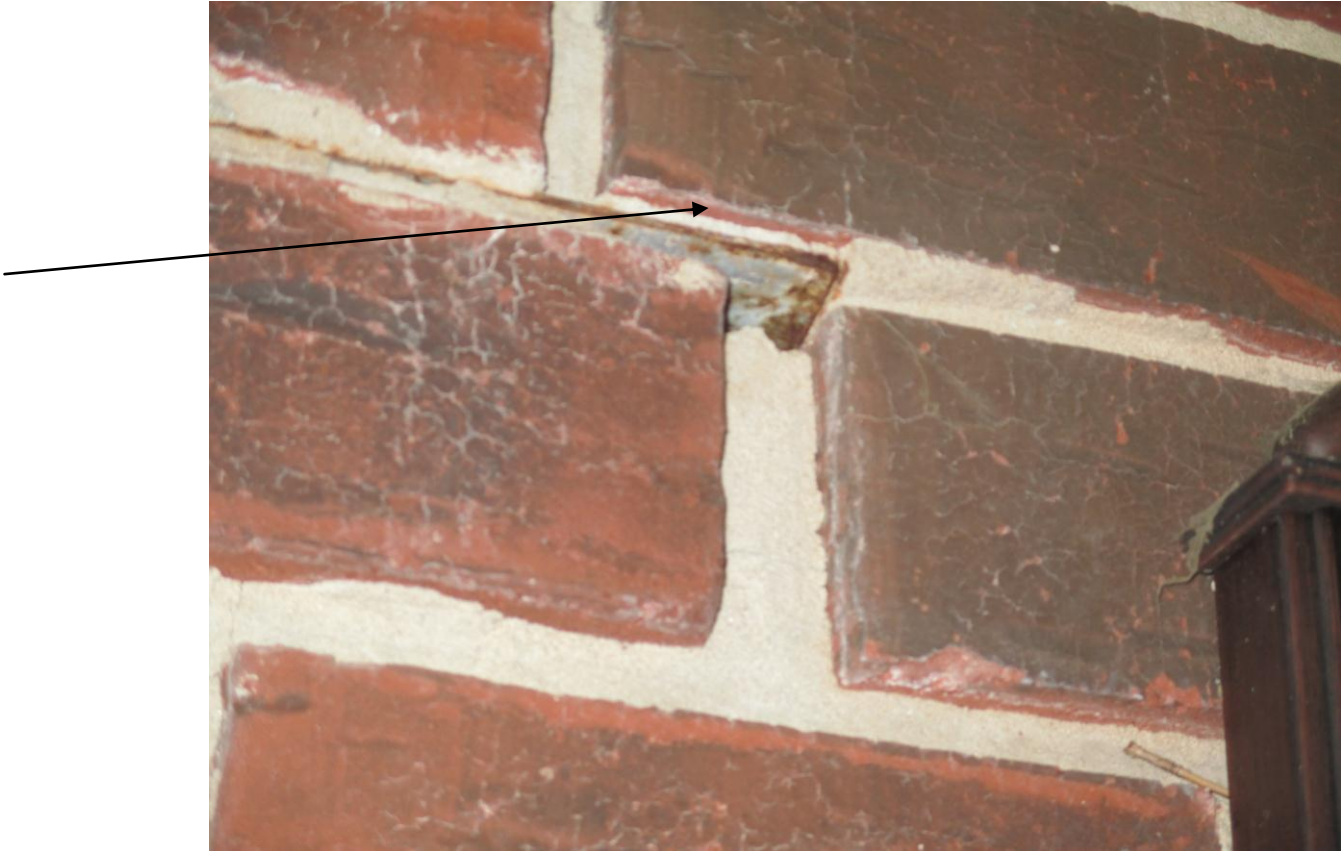
Have fireplace flue cleaned and tested before burning.
 Clean gutters on rear of home. Re-attach twodownspout extensions for positive drainage away from foundations.
 A large portion of the white exterior trim needs to be cleaned, repaired and repainted. Some rotting has taken place where wood touches wet concrete.—replace.

Brick surfaces are spotted in places. Suggest be cleaned with muratic acid. Patch up masonry joint imperfections.

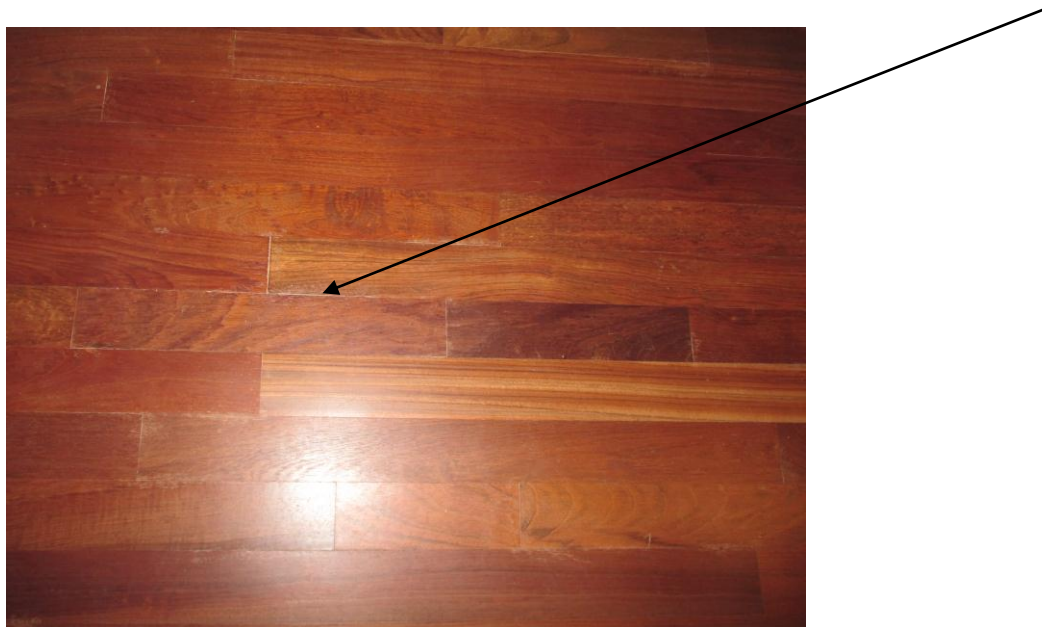
GENERAL COMMENTS **Hardwood flooring in kitchen and breakfast room need treatment to remove worn places showing as white streaks along joints.**
Lights over range not working.

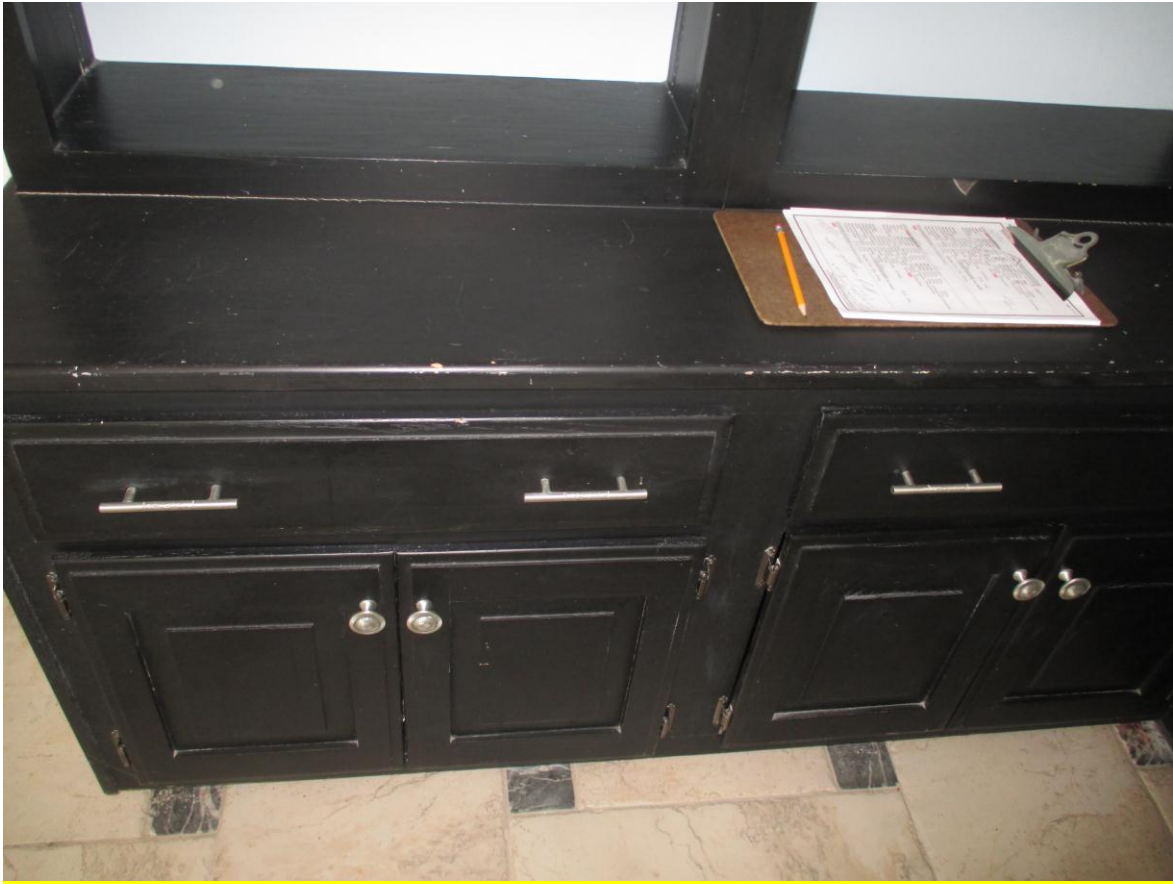
Cabinets should be repainted see photos next page.

Cabinets should be repainted or repaired in billards room
