JOE D. WORLEY  
**WORLEY AND ASSOCIATES**  
CONSULTING ENGINEERS

Memorandum To: Mr. [REDACTED]  
Subject: Structural Inspection and report

Friday March 25, 2016

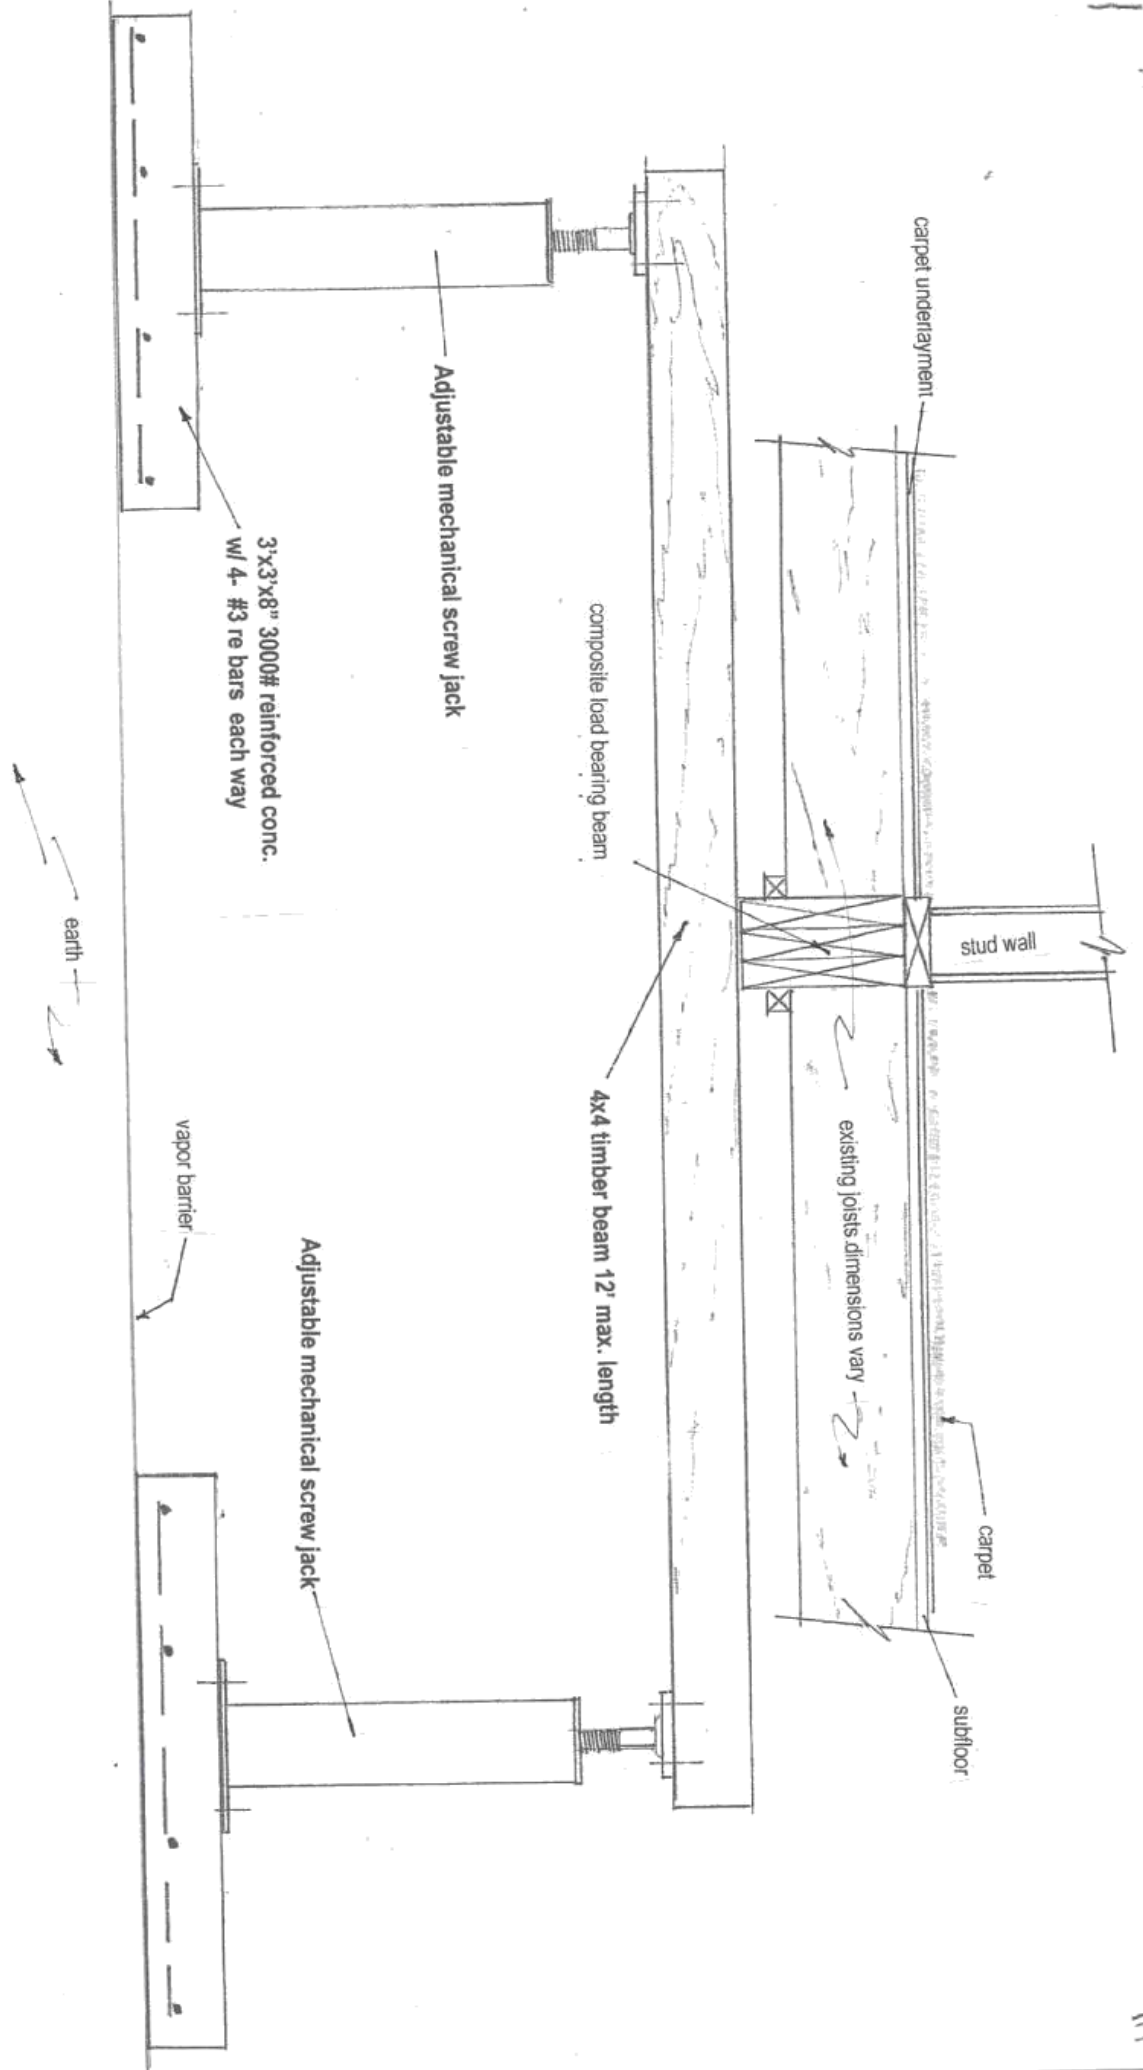
**TYPICAL SECTION OF BRACING AND MECHANICAL JACKS  
BENEATH THE BEAMS AT LOAD BEARING PARTITIONS HAVING VISIBLE  
SHEETROCK CRACKING**

In addition to having squeaking floors, you have identified several places where wall (Sheetrock) cracks have appeared on or around doorways on the first floor. These occur when the wall itself is slightly deformed due to settling of the wooden beams beneath the walls. When this deformation occurs, the stress, wherever it is in the wall, will travel to, concentrate at, and manifest itself at the nearest opening, (in this case doorways and arched openings with no doors.) Since sheetrock is a very brittle material, this can occur with only the slightest shift of the floor framing. It can be caused by settlement of the footings which can be caused by having too much load concentrated at a pier which compresses the soils beneath the footings, and / or from bending of the floor beams. Both are due to construction errors.

Most of the wall cracks are in doorways in walls supported by beams. I examined the floor structure while in the crawlspace beneath the first floor.. When viewed from the underside it is difficult to tell exactly where the walls above you actually are. However I am including a rough sketch of the first floor layout pointing out the locations where I suggest extra support be given to the wooden frame.

I am also suggesting that extra support be given under these locations by using "drop beams" with screw jacks on concrete pad footings. I am including sketches of typical installations.

Note : mechanical, plumbing and electrical equipment shall be adjusted to allow structural modifications
